## Safety alert 1: Kaatumistapaturma

### Tapaturman kuvaus

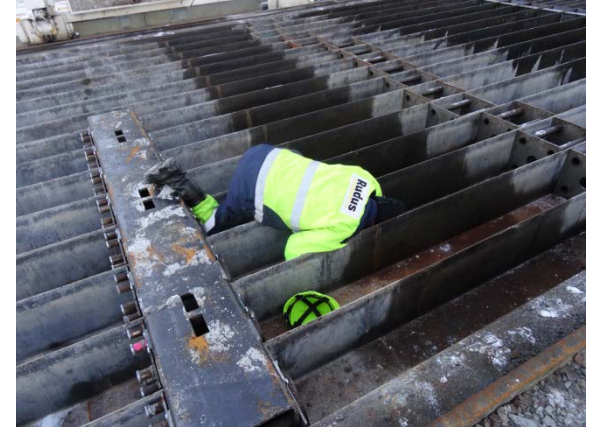
- Vahingoittunut oli poistamassa lämpöpeitettä muotin päältä nosturikuskin kanssa. Nosturilla vedettiin lämpöpeitettä muotistolta ulospäin.
- Vahingoittunut käveli muottirivistön metallireunojen päällä, lämpöpeitteen perässä välttääkseen liukkaan sen päällä kävelyn.
- Pakkanen (-18c°) aiheutti kenkien pohjien kovettumisen ja tarpeen pukeutua lämpimästi.
- Kävellessään osui metallisen massiivijigin, eli valuohjaimen kohdalle ja astui sen päälle. Astuessaan liukastui ja kaatui muotiston päälle, iskien oikean kätensä metalliseen paalumuotin reunaan.
- Syksyllä koekäyttöön tulleet massiivijigit oli todettu liian liukkaiksi ja odottivat korjausta. Ne oli kuitenkin viety muotistolle, vaikka siitä puuttui verkkopinnoite.
- Työntekijältä murtui ranne ja olkapää.

Kohta jossa kaatuminen tapahtui. Huomaa liukas valuohjain.

- Tapaturma käydään läpi pienryhmissä Nummelan, Turun ja Kurikan yksiköissä, joissa vastaava tilanne voi tapahtua. Tapaturmasta tiedotetaan koko Rudusta.
- Kaikkiin vastaaviin valuohjaimiin asennetaan karhennuslevyt.
- Kokeillaan yksikössä muotin ylittämiseen soveltuvia kulkurampeja.
- Kypäriin hankitaan leukahihnat

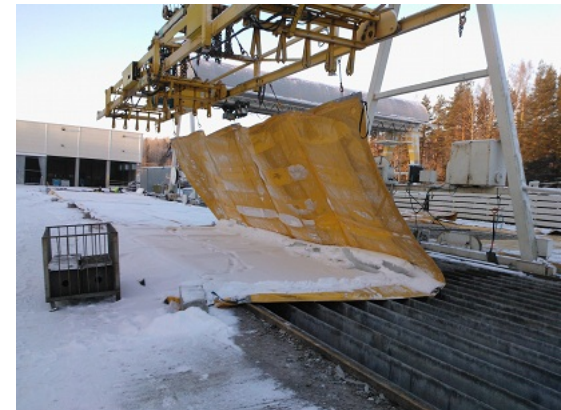
Lämpöpeitettä oltiin vetämässä pois muotin päältä.
