## Safety Alert 2: Lekatapaturma

### Tapaturman kuvaus

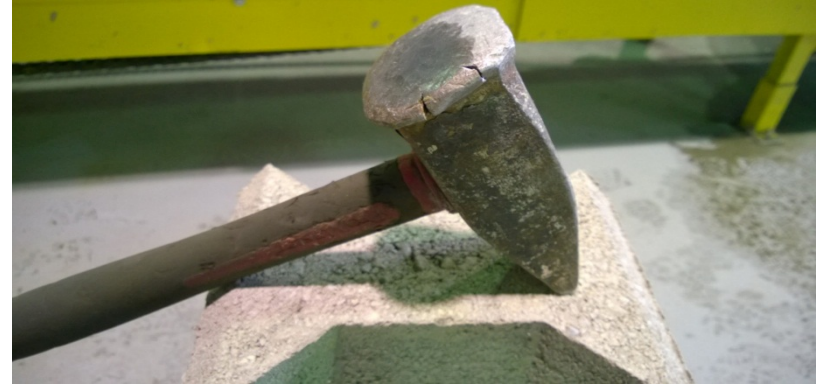
- Muurikiviä lekalla halkaistaessa lekasta irtosi iskun seurauksena metallisirpale, joka sinkosi työntekijän oikean reiden yläosaan läpäisten työvaatetuksen.
- Metallisirpale tunkeutui työntekijän reiteen noin 3 cm syvyyteen ja aiheutti kolmen päivän sairauspoissaolon.
- Pahimmillaan sirpale olisi voinut osua esimerkiksi kaula- tai reisivaltimoon.

Leka, josta irronnut metallikappale.

- Ensisijainen toimenpide on halkaisulaiteinvestoinnin toteuttaminen.
- Ennen investoinnin toteutumista tehostetaan välittömästi suojavaatetusta.
  - Entistä paksummat suojaesiliinat.
  - Kasvovisiirin lisäksi käytetään myös umpinaisia suojalaseja (tyyppi laskettelulasit).
  - Kaulan alueen suojaamiseen kiinnitetään erityistä huomiota, esim. jääkiekkoilijan kaulasuojalla.
- Lekasta poistetaan muokkaantuneet reunat säännöllisesti

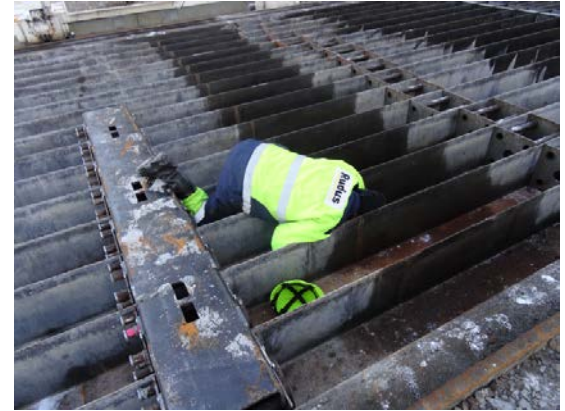
- Injured worker was removing heating blanket from top of a precast beam mold with a bridge crane.
- Injured was walking on top of mold edges, behind the blanket to avoid walking on top of the slippery blanket.
- Spikes are not allowed to be used in these conditions, because they increase slipperiness. Weather conditions of -18°C caused bottoms of shoes to harden and be more slippery. It also calls for thicker, clumsier clothing.
- When walking he stepped on top of ice metallic stopper with some ice on top. Injured slipped and fell over on the mold, hitting his right hand.
- Worker's shoulder and wrist were broken.

Place where accident happened  
notice slippery stopper

- Accident will be discussed in toolbox talks at the units of Turku, Nummela and Kurikka, which operate in similar conditions. Whole Rudus will be informed about accident.
- Safety grids will be installed in all metal stoppers.
- Walking ramps will be taken into testing in order to make crossing of mold safer.
- Chin straps will be installed in all helmets to stop them from falling off when tripping over.

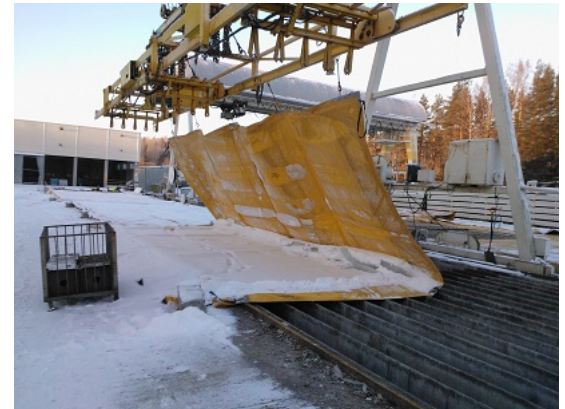
Heating blanket was being removed from  
top of mold
