## Safety Alert 1: Tripping injury

### Accident description

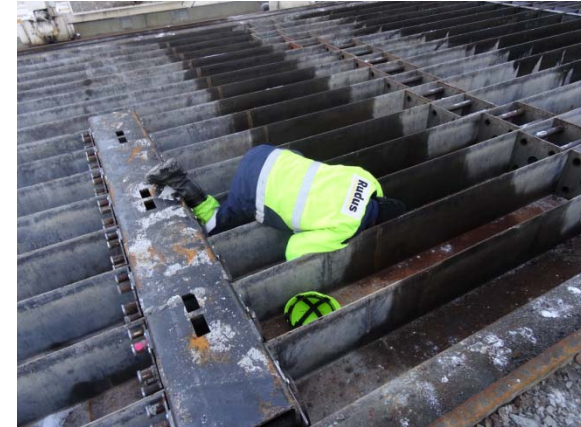
- Injured worker was removing heating blanket from top of a precast beam mold with a bridge crane.
- Injured was walking on top of mold edges, behind the blanket to avoid walking on top of the slippery blanket.
- Spikes are not allowed to be used in these conditions, because they increase slipperiness. Weather conditions of -18°C caused bottoms of shoes to harden and be more slippery. It also calls for thicker, clumsier clothing.
- When walking he stepped on top of ice metallic stopper with some ice on top. Injured slipped and fell over on the mold, hitting his right hand.
- Worker's shoulder and wrist were broken.

Place where accident happened  
notice slippery stopper.

- Accident will be discussed in toolbox talks at all units, which operate in similar conditions. Whole company will be informed about accident.
- Safety grids will be installed in all metal stoppers.
- Walking ramps will be taken into testing in order to make crossing of mold safer.
- Chin straps will be installed in all helmets to stop them from falling off when tripping over.

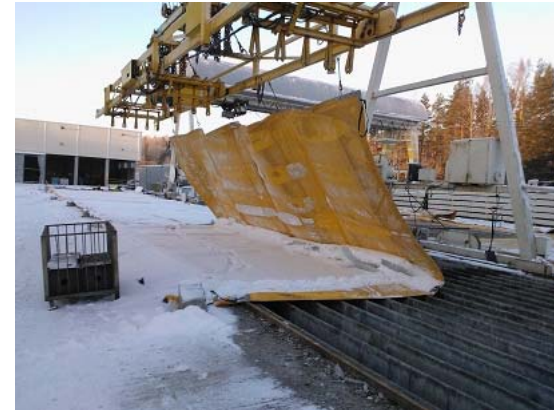
Heating blanket was being removed from  
top of mold.
