## Safety Alert 3: Electric shock accident

### Accident description

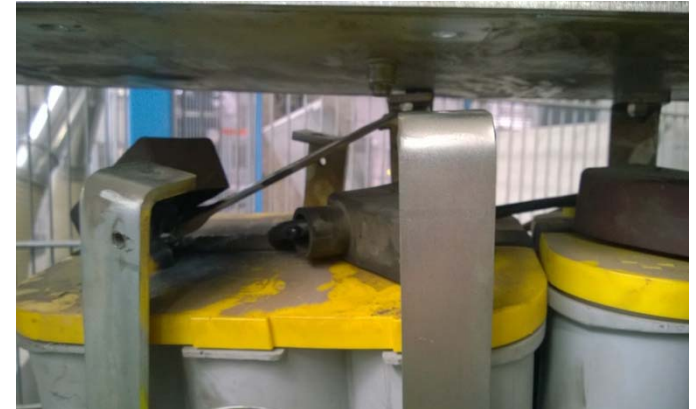
- The electrician was opening the nut in the last bracket iron of battery no. 2 with a spanner. The other end of the spanner touched the plus pole of the battery which was exposed because its rubber cover had become displaced.

- The causes of the accident include e.g. the lack of a risk assessment and work planning, the zero wire had not be disconnected from the frame, the nut was opened with an uninsulated tool although work involved a risk of the spanner touching live parts, and structural weakness of the rubber cover (is displaced at a light touch).

The spanner was caught between the plus pole and the nut causing a short-circuit and arcing.

- The accident will be reviewed in small groups in all the units where a similar accident could occur.
- A detailed work instruction will be drawn up for the replacement of batteries.
- The use of appropriate tools is taken into account in the work instruction.
- Preparations will be made from now on for the replacement of batteries so as to ensure that it can be carried out by one person (more space, better visibility). An adjustable work platform will be introduced on which the batteries can be supported during replacement.

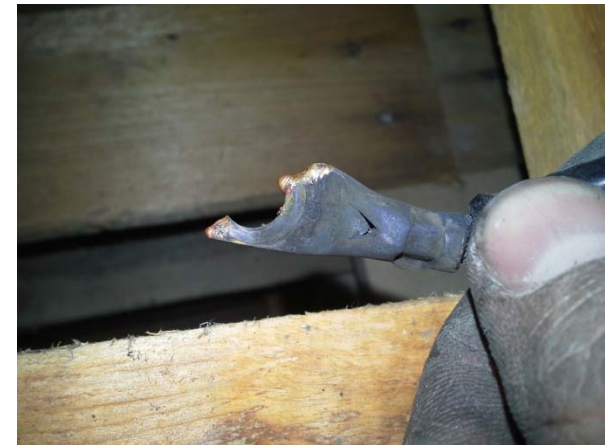
The connector of the plus pole on the frame under the fastening screw of the last (no. 4) battery melted as a result of the short-circuit.
