## Safety Alert 13: Falling over of wall panel on truck platform

### Accident sequence

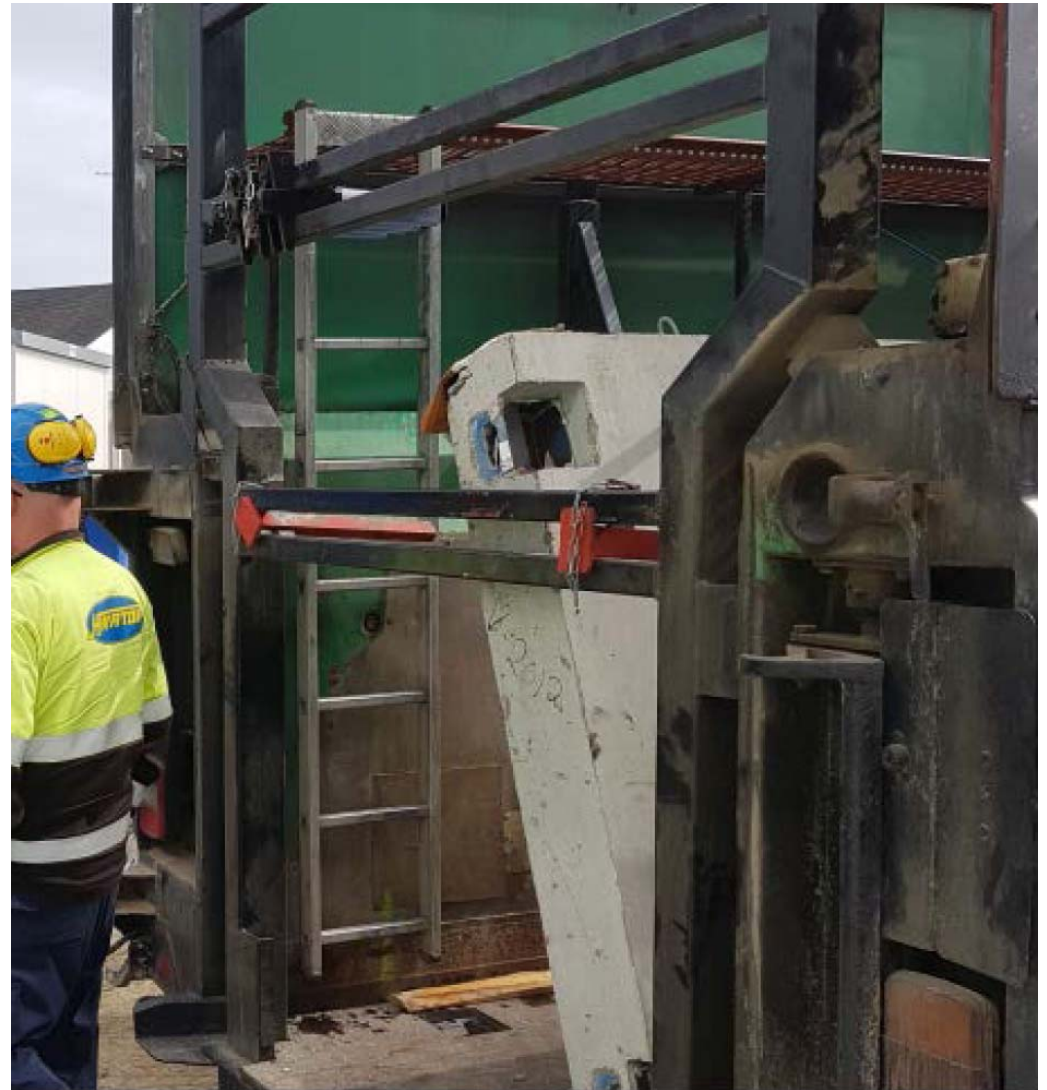
When unloading an inloader truck, a wall panel considerably lower than the others (height 160 cm, length 6.7 m, weight 5.1 tons) was the last one to be unloaded. It was the only panel that had been loaded in the rear section of the rack.

The driver decided to remove the locking key of the pin supporting the panel, presumably to speed up the lifting of the last panel. The driver obviously considered the single chain pulled round the panel to secure it adequately. The crane was unloading the previous panel into the worksite stacking rack.

As the driver got the key loose, the panel immediately fell on him. The driver was crushed under the panel until the worksite crane managed to lift the panel off him. The driver was left with broken ribs on his left side and a fractured spleen.

The securing chain had been placed asymmetrically round the panel. On the side which was facing the driver and which fell down, the chain was almost horizontal and fixed to the platform structures at a height of about 140 cm, while the other end of the chain was almost vertical and fixed to the platform floor. As a result of the abnormal placing of the chain, the forces in the tensioned chain contributed to the falling of the panel. The driver probably did not realise this when he removed the pin. As the panel moved slightly, the single securing chain became loose and the part of the chain chafing against the top corner of the panel could no longer hold the falling panel. If the panel had been of the same height as the other panels, the position of the chain would not have been such a big problem, and the panel would probably have remained upright even without the pin.

Clear lists shall be drawn up for each company and product of all the do's and don'ts at every stage of unloading and loading.

Safety Managers shall verify that the list is carefully studied with every driver.

It shall be ensured that also self-employed contractors are given adequate training in the safe handling of precast panels.

It shall be checked that new employees of transport firms have been provided with adequate induction in safety matters.
