Safety Alert 2: Accident with a sledgehammer

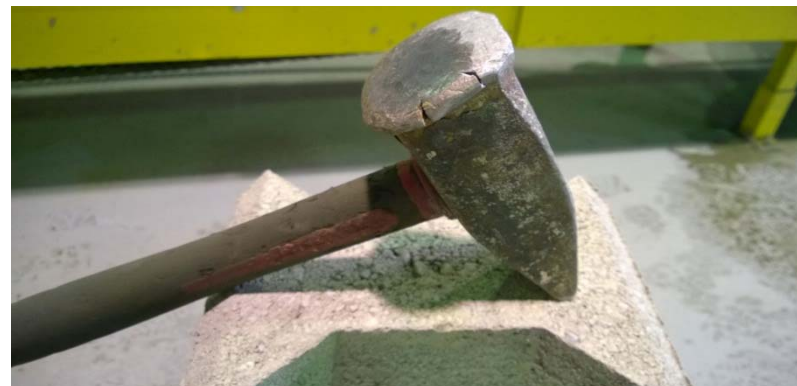
- When wall stones were being split with a sledgehammer, a metal fragment came off the sledgehammer, and flew onto the upper part of the worker's right thigh, penetrating his work clothes.
- The metal fragment penetrated into a depth of ca. 3 cm in the worker's thigh causing a three-day absence from work.
- At worst, the fragment could have hit e.g. the neck or thigh artery.

The sledgehammer from which the metal fragment came off.

- The primary action is to invest in a stone cutting device.
- Prior to the implementation of the investment, protective clothing shall be improved immediately.
 - Thicker protective aprons than before.
 - In addition to a face visor, also full cover goggles are to be used (type ski goggles).
 - Particular attention shall be paid to the protection of the neck area, using e.g. a hockey player's neck guard.
- Brittle edges shall be removed from sledgehammers on a regular basis.
