Safety Alert 7: Failure of lifting lug on concrete hopper

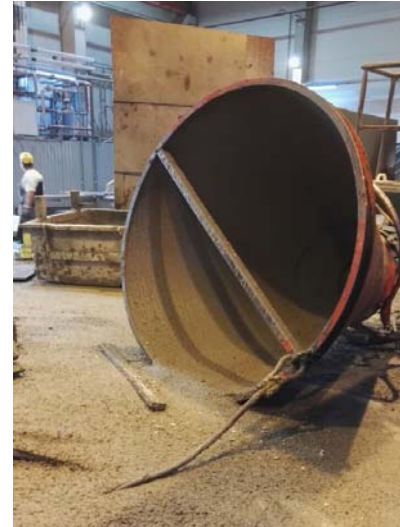
- As the concrete hopper was being transferred with a crane, the lifting lug on the hopper failed and the hopper fell on the ground.
- Personal injuries were avoided, but the incident was severe because there were people working near the area where the hopper fell.
- The lifting lug of the hopper had already been welded before, but the hopper had not been inspected after the welding.

Concrete hopper fallen on the floor.

- All lifting accessories used at the plant will be inspected.
- Lifting accessories which are lacking an inspection stamp, or have been repaired by welding or modified after inspection will be immediately removed from use.
- These lifting accessories will be either disposed of or repaired according to the manufacturer's instructions and then submitted for re-inspection and approval stamping.

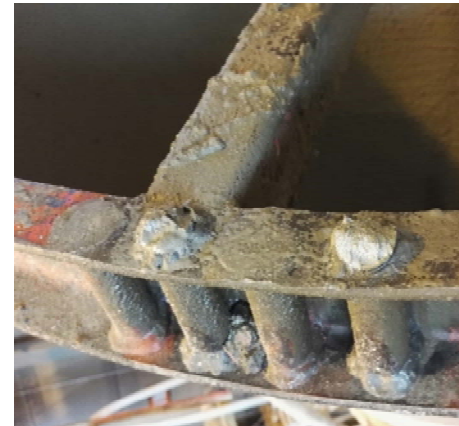
Broken lifting lug on the concrete hopper.
